Inherent hazards, poor reporting and limited learning in the solid biomass energy sector: a case study of a wheel loader igniting wood dust, leading to fatal explosion at wood pellet manufacturer

Project No.
Document no. Aars 2010
Version 20
Date of issue April 4, 2014

Large loaders are commonly used when handling solid biomass fuels. A preventable accident took place in 2010, where the malfunction of a front-end wheel loader led to a dust explosion which killed the driver and destroyed the building. The case offers an opportunity to examine the hazards of solid biomass, the accident investigation and any learning that subsequently took place.

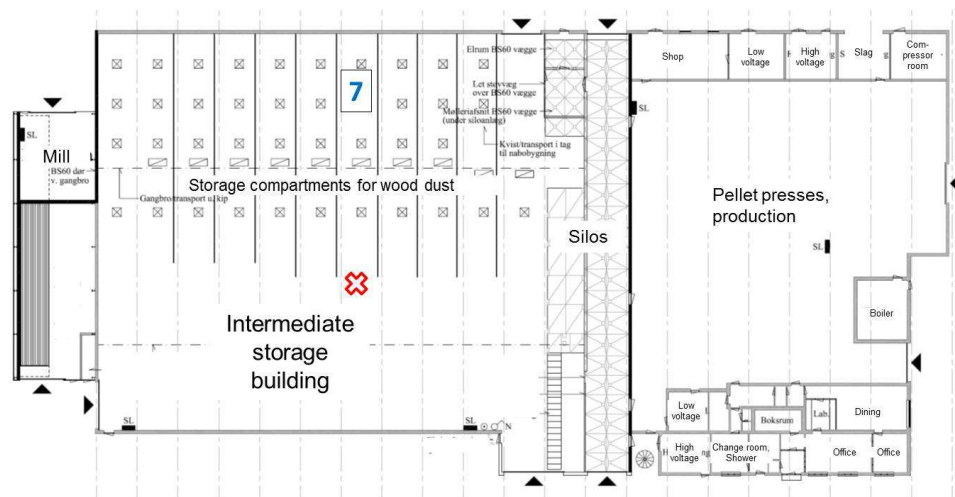
The intermediate storage in building II (40m x 50m) comprised 9 storage compartments for wood dust (Figure 2). Each compartment was about 25 m long and wide enough for a wheel loader to enter, shovel up material and bring it to the dust mixing pit. Wood dust was dumped into the cells from a band conveyor connected to a wide flexible hose that extended down to the floor to limit dust generation. A sensor would raise the hose as the pile grew in size. This area was designated ATEX zone 22 (dusts): defined as an explosive atmosphere not likely to occur in normal operation and if it does occur, it will exist only for a short time. Safety engineering control measures included extensive mechanical local exhaust ventilation, magnetic separation of tramp iron upstream from the mill with spark, fire detection and sprinkler system downstream the mill. At the end of each shift the wheel loaders were cleaned with compressed air to prevent accumulations of dust.

Figure 2 Layout of Building II showing wood dust storage hall, production hall and hopper arrangement in between. Accident compartment seven is marked. Fat black line shows A60 firewalls. Source: Company application for environmental permit, dated Jan 28, 2010)

Following this line of reasoning a superior and inherently safer design philosophy at Dangrønt would be to mix the recipe of raw materials and

immediately process wood dust from the mill into pellets, eliminating the intermediate storage. This would eliminate the hazard, a 500 t buffer storage of combustible dust, i.e. primary prevention. From an organizational perspective [24], [25], the root cause would be a failure to address principles of inherent safety at the design stage; other contributing factors such as the usage of wheels loaders would be derived secondary unsafe practices.
